The Performance of Low-Rise Open Span Heavy Steel Structures In Extreme Winds

Joe R. Charlton, B.S., P.E.

A REPORT

CIVIL ENGINEERING

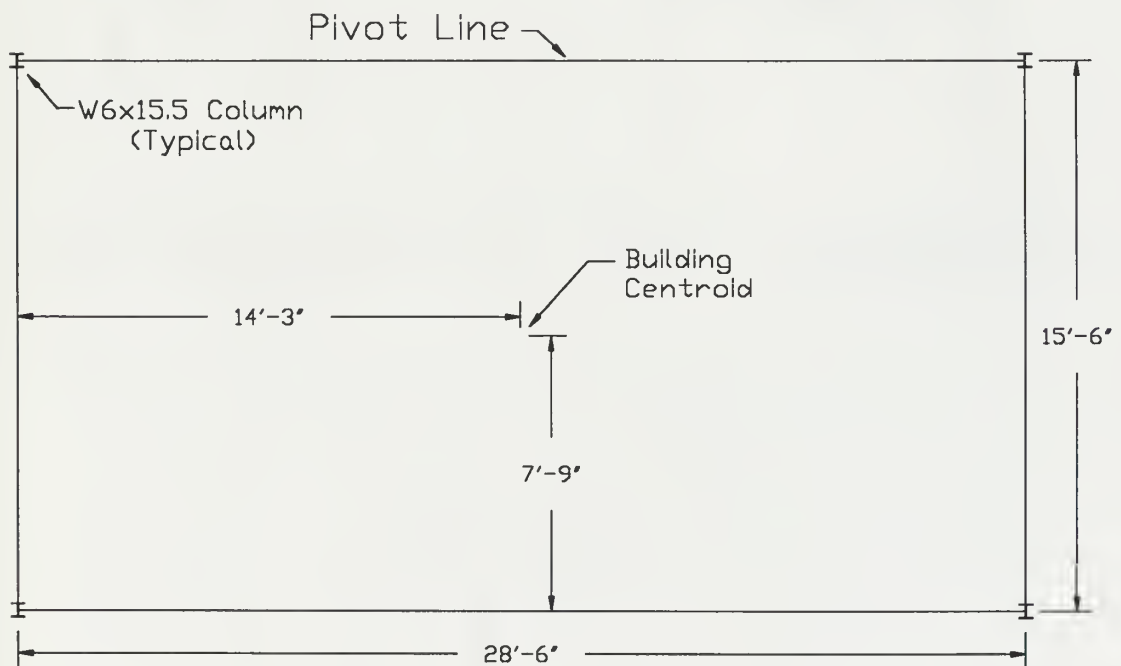
Figure 4.4 Drawing, Plan View of Parachute Tower

The parachute drying tower is a steel frame structure that is 15'-6" wide, 28'-6" long, and 62'-4" tall. The tower has four wide flange steel columns and various wide flange beams. A plan view of the structure can be seen in Figure 4.4. The tower is structurally braced against sidesway by double angles that are attached to the four columns at intermediate levels as shown in Figures 4.5 and 4.6. These cross braces transfer the lateral loads into the columns and the columns transfer the loads into the foundation via base plates and four 5/8" diameter A307 bolts as shown in Figure 4.7. The exterior walls of the tower are covered with corrugated asbestos siding.

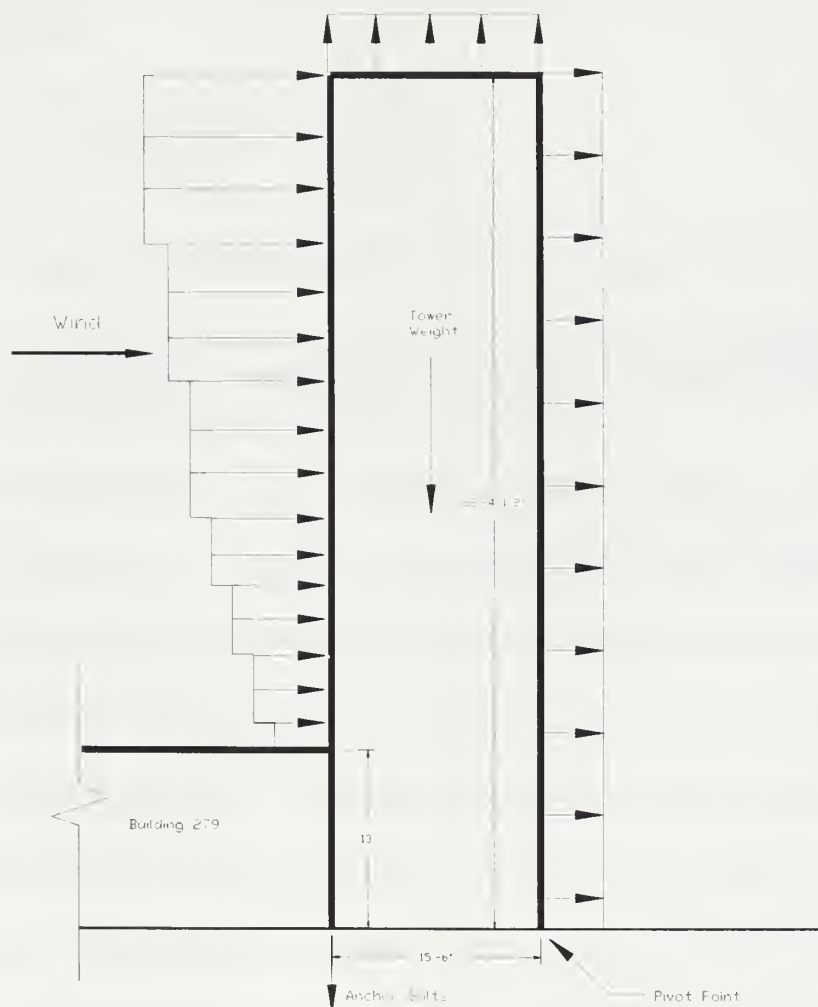
Figure 4.11 Forces Acting on Parachute Tower

The wind that caused the collapse of the parachute tower was generated by the Altus, Oklahoma tornado that was described earlier in Section 3.5. The wind caused the collapse of the parachute tower by generating enough force to cause failure of the column anchor bolts and also overcome the righting moment generated by the weight of the building. An illustration of the forces acting on the structure can be seen in Figure 4.11, below.

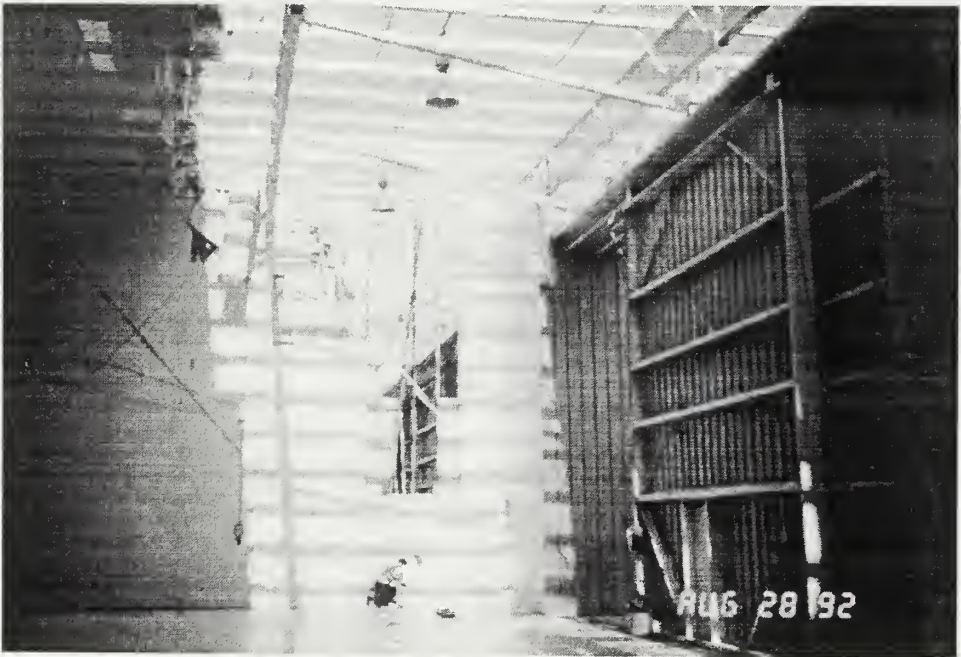
Figure 4.26 Interior Elevation of Beechcraft Hangar

The Beechcraft hangar shown in Figures 4.23, 4.24, and 4.25 is approximately 200 feet long, 60 feet wide, and 40 feet tall. The structure has a gable roof with a very slight pitch (approximately 1/4" per foot). The exterior walls are covered with corrugated metal siding and the roof is covered with corrugated metal decking. The main structural system is made up of wide flange steel columns, large custom girders, and z shape roof purlins. The lateral loads are transferred to the foundation via steel cross bracing running between the columns. All of the main structural elements can be seen in Figure 4.25. The other two hangars that are shown in Figure 4.26 are very similar in size and construction to the Beechcraft hangar.

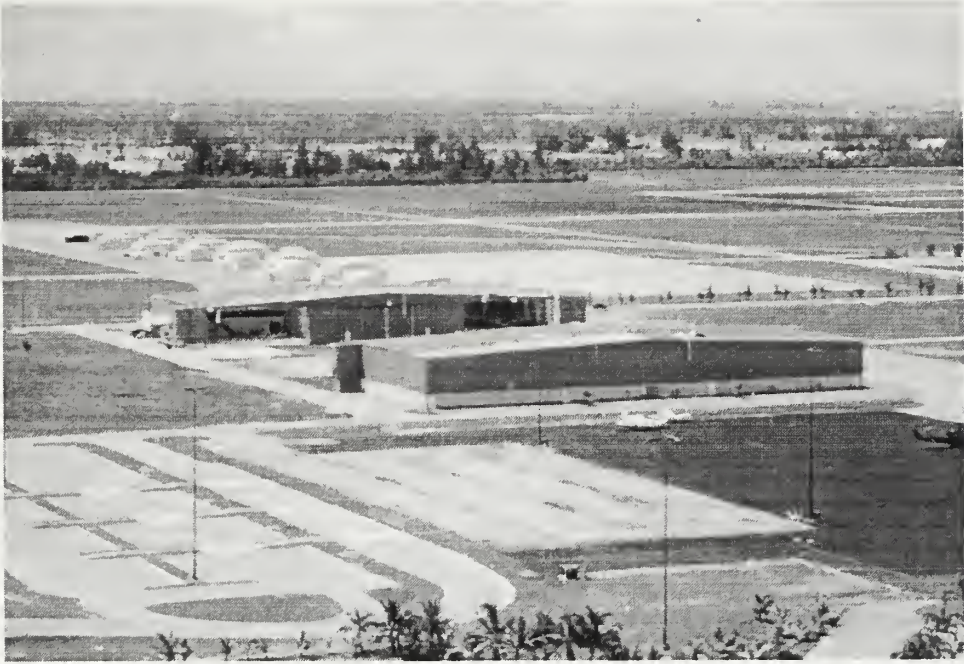
Figure 4.27 Aerial View of Two Damaged Hangars

The main component that was damaged on all three hangars was the roof decking. The corrugated siding on the front of the Beechcraft hangar also received minor damage at the door pocket, see Figure 4.25.
